WARRINGTON TOWNSHIP RETENTION BASIN

PHASE I INSPECTION REPORT
NATIONAL DAM INSPECTION PROGRAM

NDS I.D. NO. PA 01066,
DER I.D. NO. 9-176

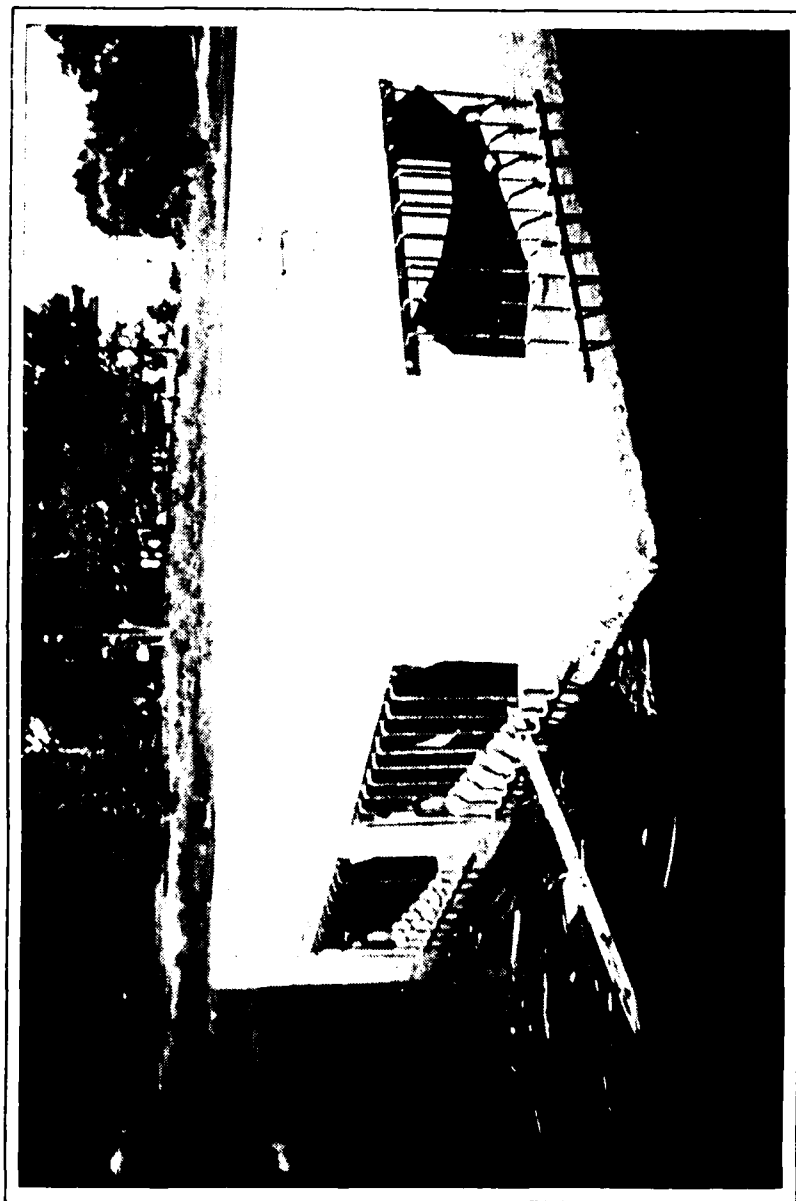
RISER WITH INSIDE DIMENSIONS OF
8 FEET BY 14.7 FEET.
